WATER & WASTES DIGEST

40 Feet Deep & About to Fail

A complex pipe repair in New York’s Tomhannock Reservoir

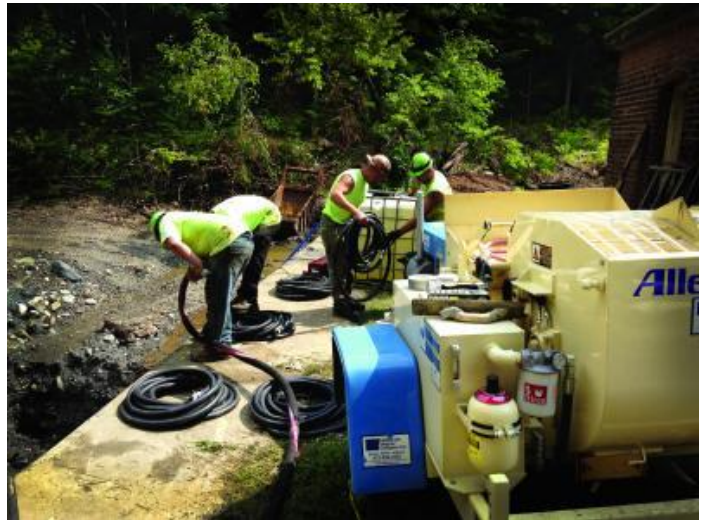
The minimal staging area required made CCCP technology an ideal solution for this project.

The minimal staging area needed, in particular, was key for the Tomhannock project. Arold realized that he could set up the spincaster's withdrawal winch in the diffusion chamber and run in power, air and concrete hoses from outside the dam and through the 30-in. diffusion pipes.

With the 60-in. pipe repaired and dewatered, the actual CCCP process was relatively straightforward. In this case, the design called for a 1-in. application of AP/M Permaform's PL-8000, a cementitious grout mixed with fibers for high tensile strength. That would have been more than sufficient, but Baldwin actually went a bit thicker.

"We ended up taking five passes, and applying a little over 1.5 in.," he said. "Coverage or structural integrity wasn't a problem, but the riveted pipe has thick bolt heads, and we wanted to be sure we were covering them completely—on some projects, we want to be extra sure we won't be coming back."
